RURAL ENERGY PROGRAM

ENVIRONMENTAL MANAGEMENT PLAN FOR MACHAKHELA SMALL HYDROPOWER REHABILITATION PROJECT

Prepared for: USAID / Caucasus
25 Atoneli Street
0105 Tbilisi, Georgia

Prepared by: Rural Energy Program 26 Dzmebi Kakabadzebi Street, Tbilisi,
0105, Georgia
Tel: +995 32 50 63 43
Fax: +995 32 93 53 52

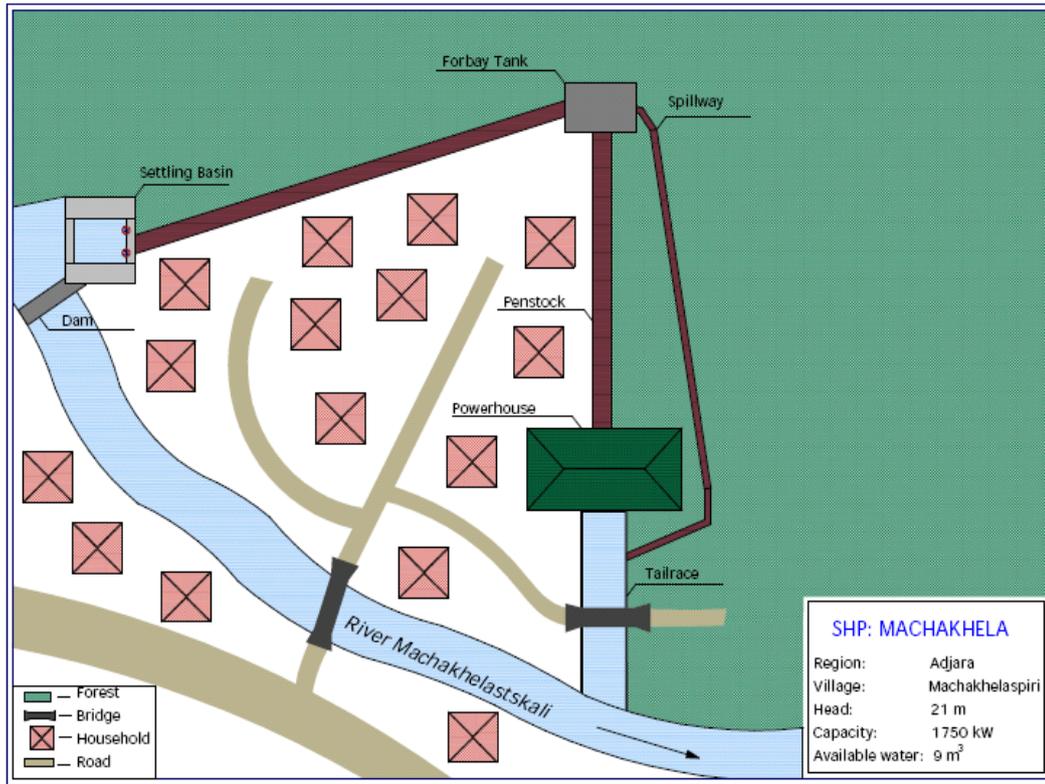
Figure 2. Layout of the Machakhela Small Hydropower Plant

The layout of the facility is presented in Figure 2:

- The low height diversion weir is 50 meters long.
- The settling basin and silt tank (15 meters X 57.5 meters) located on the left bank of the river. Intake is equipped with flow regulating and flushing gates.
- Water from the settling basin flows into the open rectangular form concrete canal which continues to the forebay tank. Canal is equipped with three emergency spillways.
- Water from the forebay tank flows into the 53.5 meters long and 1.300 mm in diameter double penstock, which conveys water to the two horizontal setting Francis turbines in the powerhouse.
- The used water is discharged back to the Machakhela River through tailrace.
